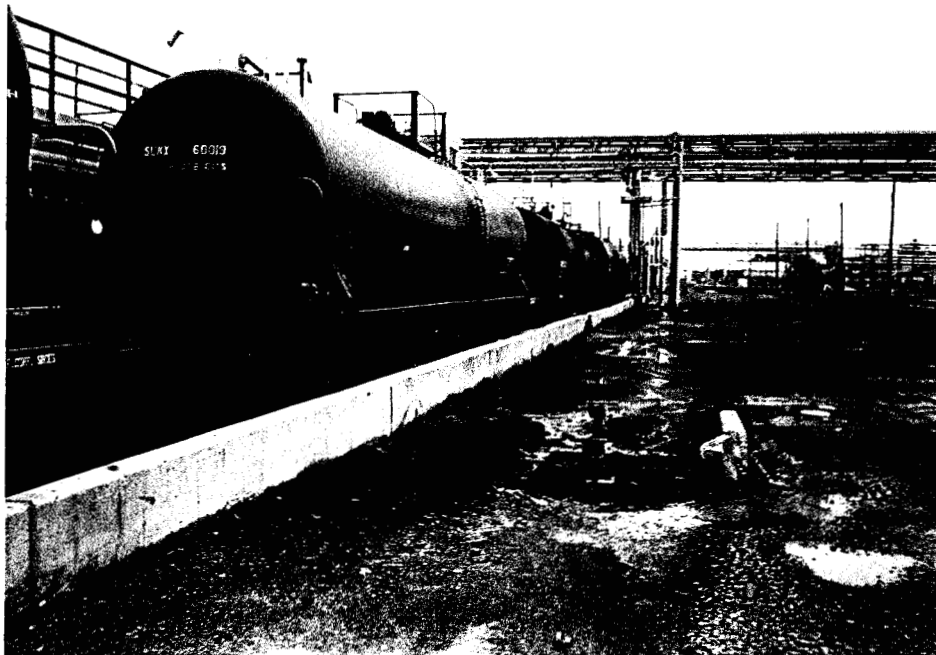
- 95.10 Combined Process/Storm Sewer System. View facing east toward a storm sewer drain and valve for the portion of Rail Car Loading/Unloading Areas and Associated Tracks (SWMU 99) located to the east of Hewes Avenue. Discharge from this drain is routed to the Middle Creek Surface Drainage System (SWMU 96).

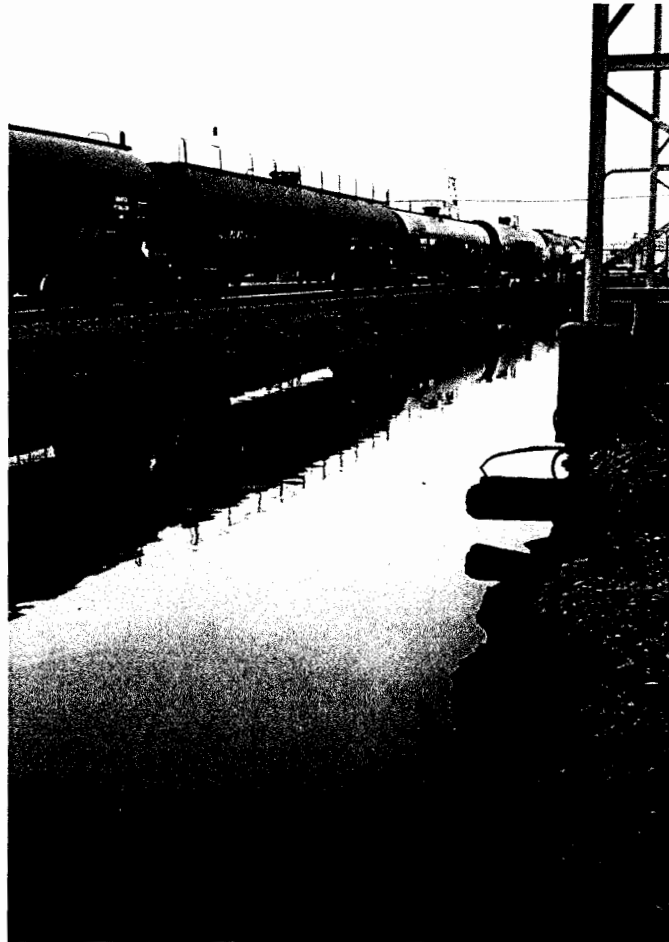
96.4 Middle Creek Surface Drainage System. View facing west along Middle Creek just south of the Heat Exchanger Bundle Cleaning Area (SWMU 62). Note heavy sludge accumulation along the banks of the way.

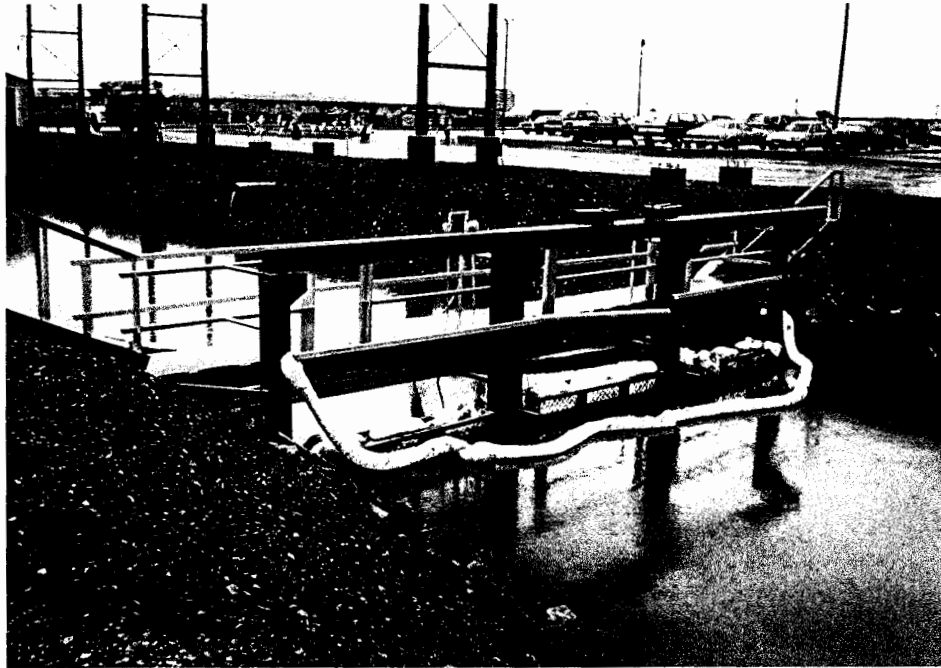
96.5 Middle Creek Surface Drainage System. View facing southeast toward a caged boom area just west (downstream) of the interceptor dam on Middle Creek. Note the concrete walls of Impoundment Tank T-101 (SWMU 32) in left background.

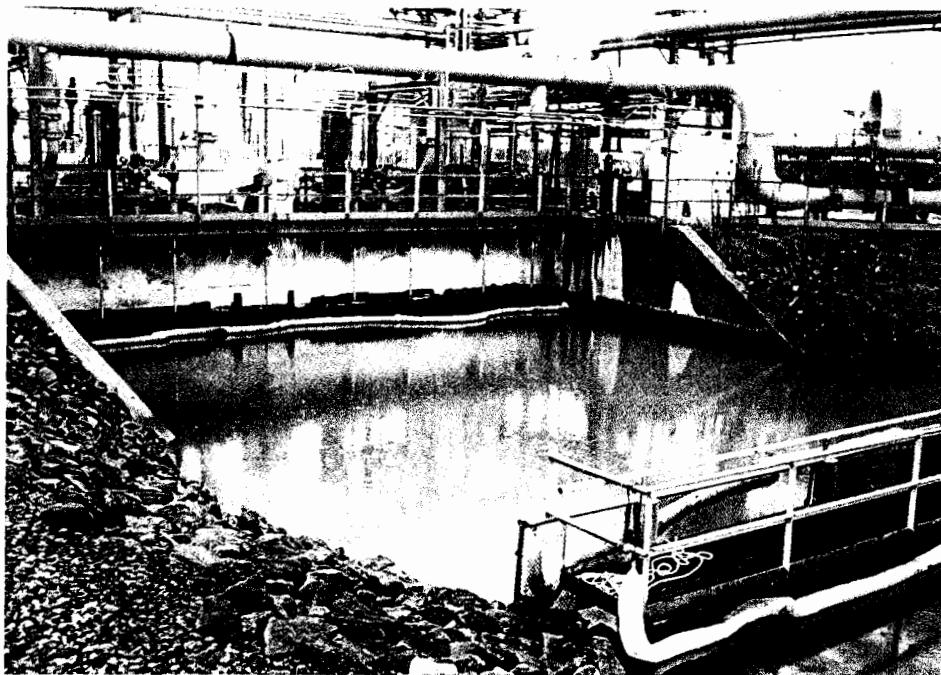
96.6 Middle Creek Surface Drainage System. View facing east showing the west (downstream) side of the dam for Middle Creek. The caged boom in the foreground is approximately 100 feet east of the booms in Photograph 96.5.

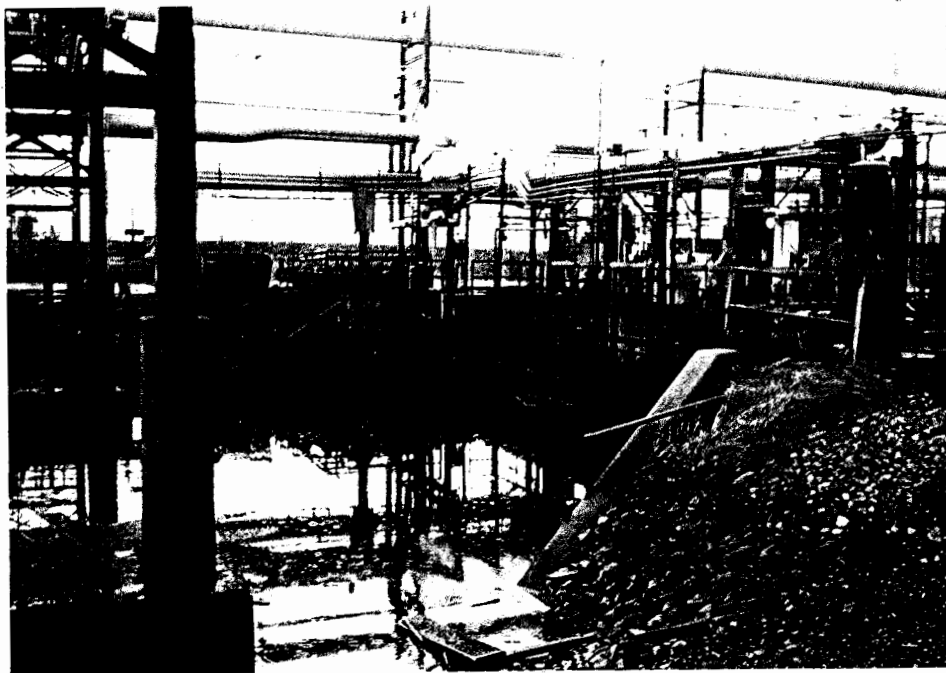
96.7 Middle Creek Surface Drainage System. View facing southwest toward the east (upstream) side of the dam for Middle Creek. Note the heavy staining in the creek and surrounding areas. The overhead pipes are to the DELCORA POTW.

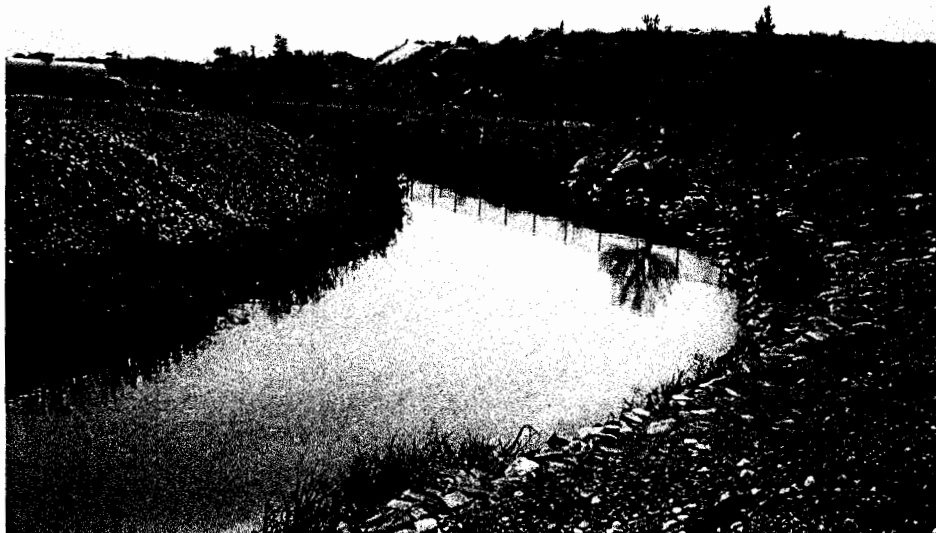
96.9 Middle Creek Surface Drainage System. View facing southwest of Middle Creek near the point where it discharges to the Delaware River beyond the Middle Creek Dam.

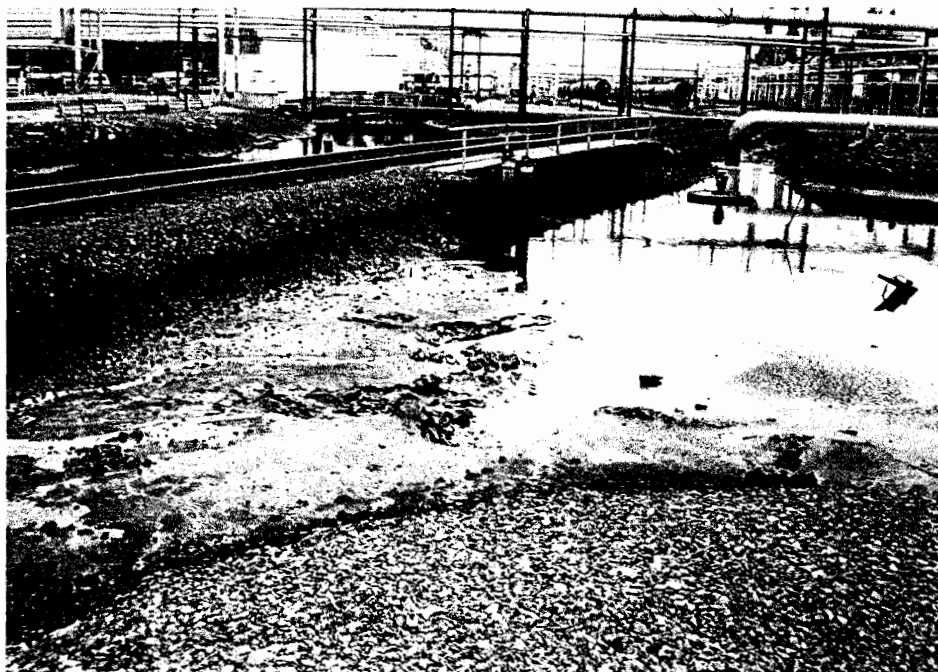
96.10 Middle Creek Surface Drainage System. View facing northeast of a portion of Middle Creek east of the Solid Waste Facility. Note the heavy accumulation of sludge in the creek.

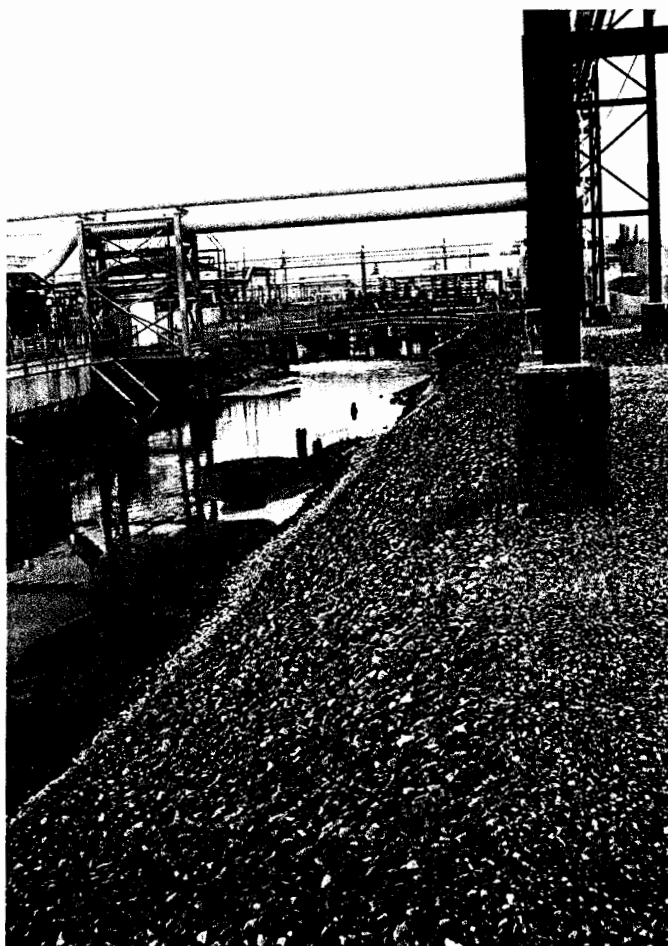
96.12 Middle Creek Surface Drainage System. View facing northeast toward a portion of Middle Creek downstream from the interceptor dam. The white overhead pipes lead from the 15 Oil/Water Separators (SWMUs 87 - 94) (located to the left and behind the photographer) to the off-site DELCORA POTW. Note the staining and sludge-like material along the closer edge of the creek.

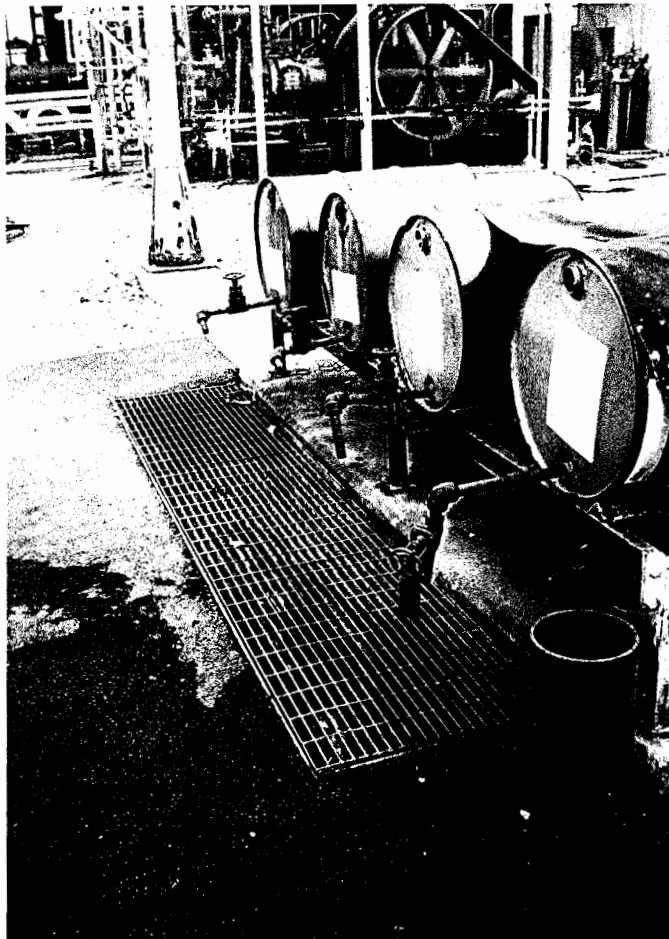
97.4

Product Drip Collection Areas. View facing north toward a large drip collection area near the Dock No. 2 Recovery Well System (SWMU 51). Drillage from connections between refinery piping and hoses used to load tanker ships is collected in a shallow, grated, concrete basin. The collection area does not have a drain.

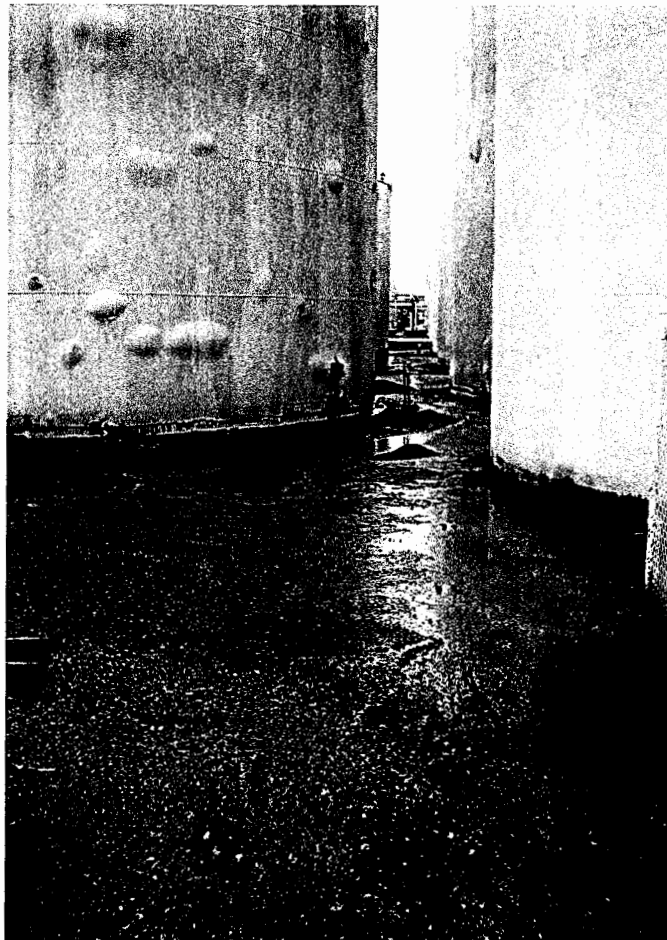
98.10 Above-Ground Tank Containment Areas. View facing north
toward a pipeline for tanks in the H-13 Tank Farm
containment area (SWMU 98).

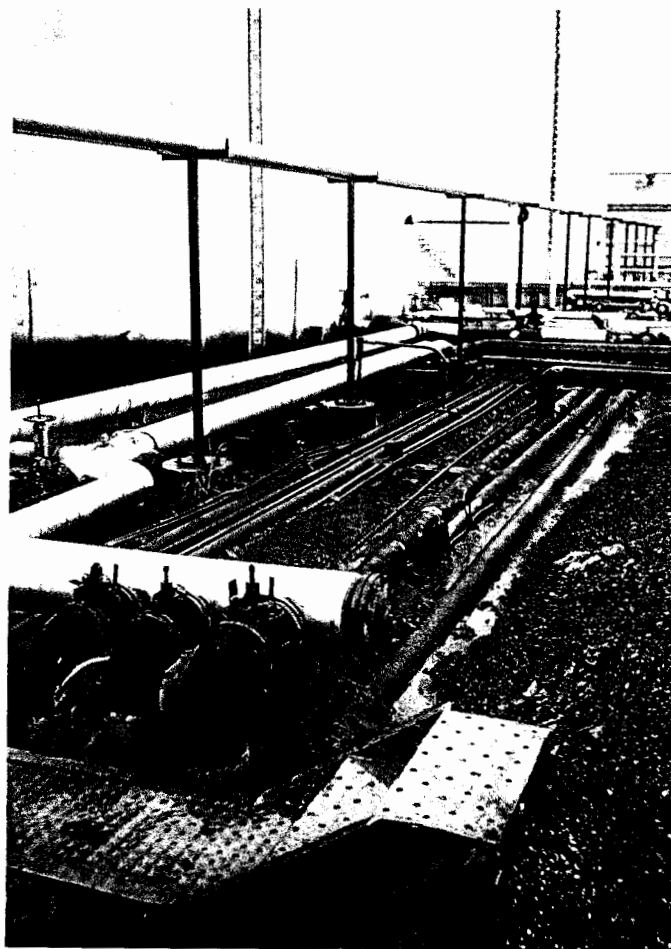
- 98.11 Above-Ground Tank Containment Areas. View facing west toward the containment area for Tank 211 located west of the 1A Oil/Water Separator (SWMU 63). Note the sump and drain for the area.

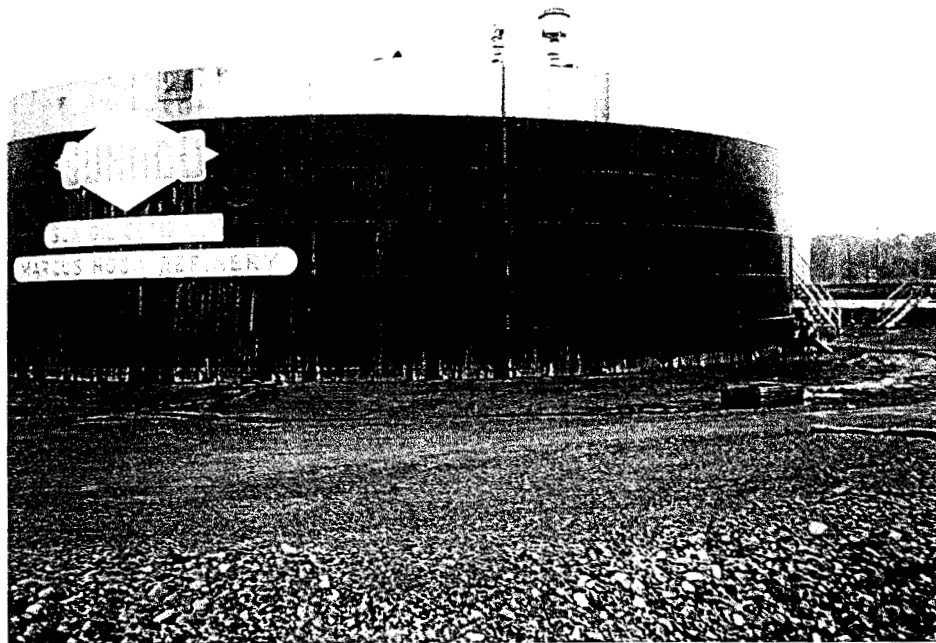
- 98.12 Above-Ground Tank Containment Areas. View facing south toward an old containment area for a slop oil tank. The tank was recently removed. Note the oil saturated conditions on the ground surface.

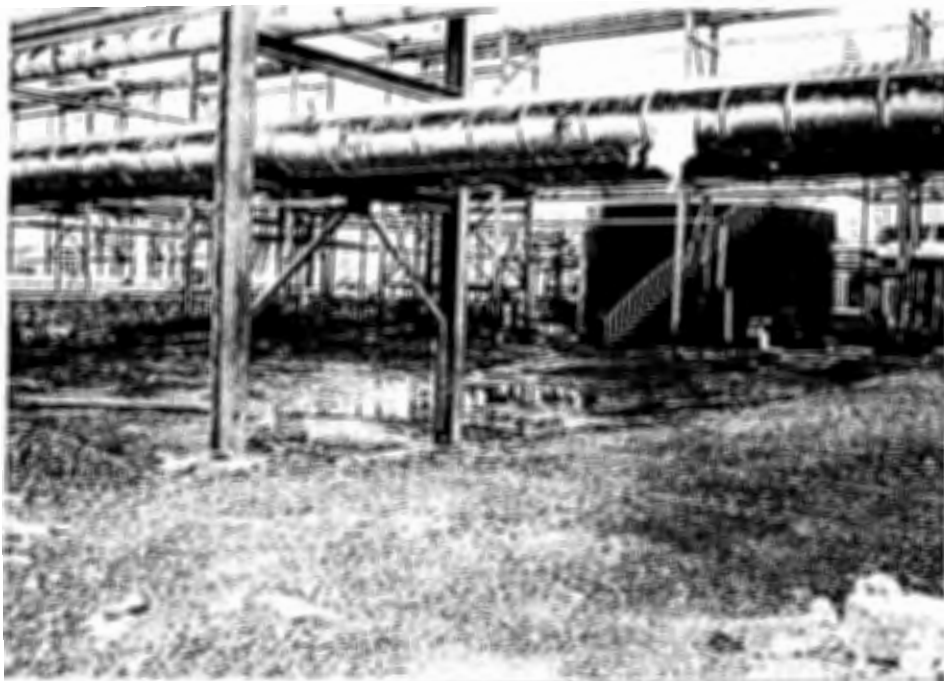
99.1

Rail Car Loading/Unloading Areas and Associated Tracks.
View facing east of the railroad tracks near Middle Creek Road. Note the heavy oil staining in the area, due to drains in the area which back up and deposit oily water.

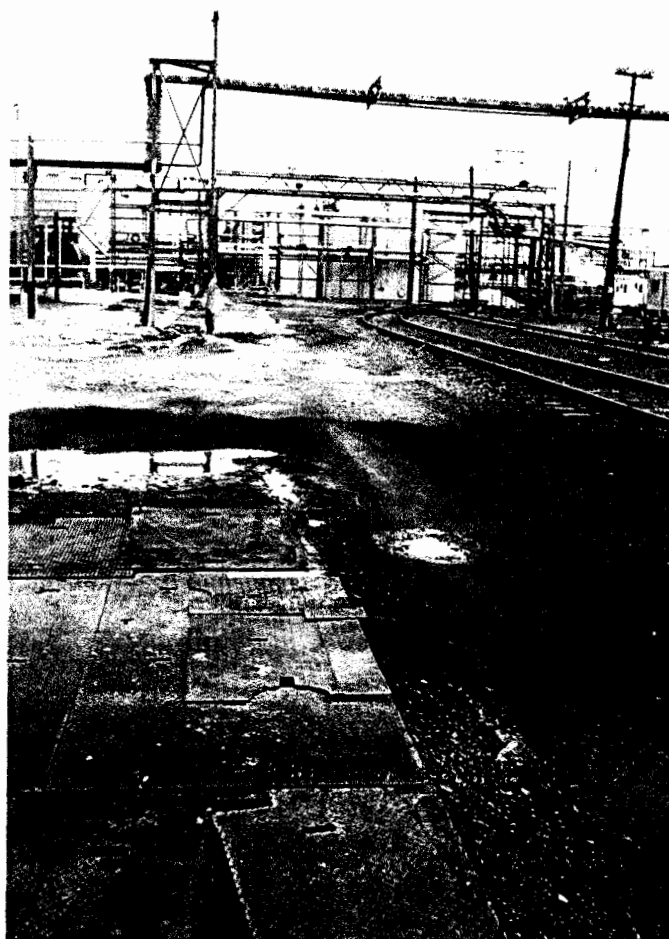
A.2 Stained Refinery Areas. View of north side of Tank No. 32. Note the spillage and the lack of containment for the tank. Spillage may be from valve system.

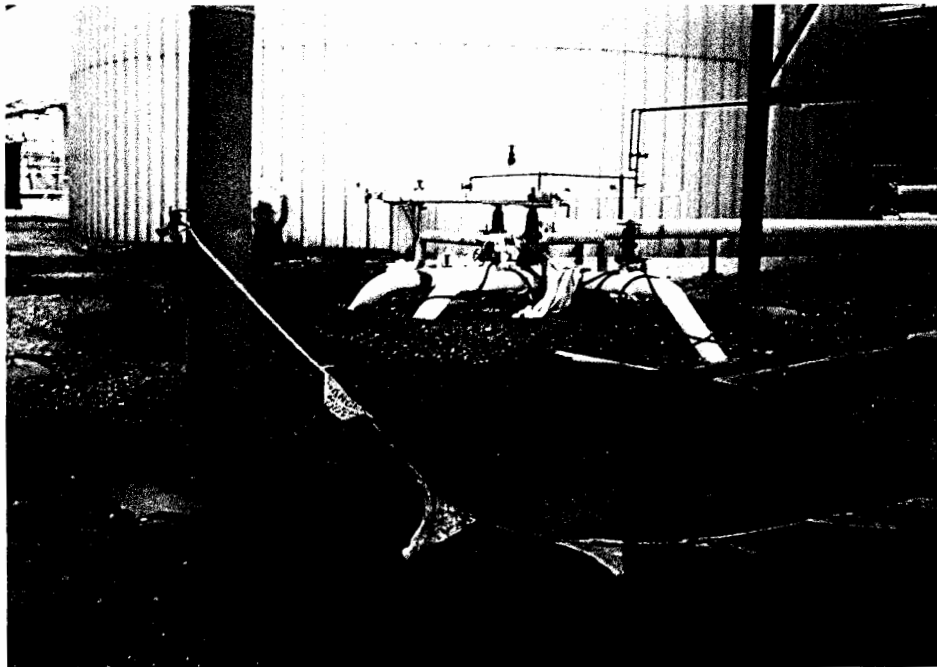
A.3 Stained Refinery Areas. View facing north toward a pump area located to the northwest of the 1F Oil/Water Separator (SWMU 68). Note the heavy spillage and stains in the area.

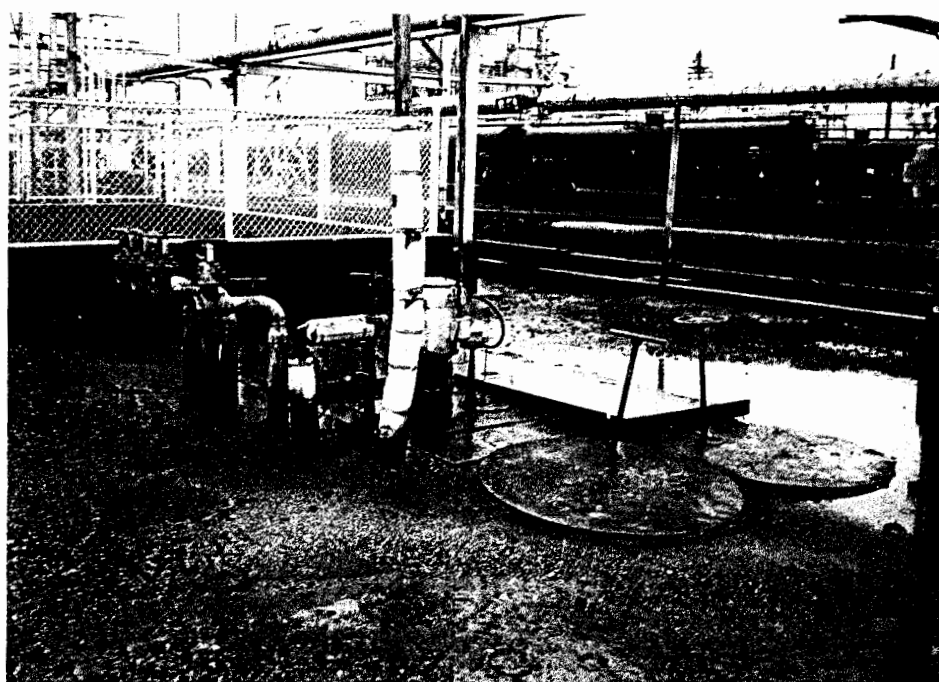
G.2 1F Oil/Water Separator Electrical Box. View facing southeast toward the control system for the 1F Oil/Water Separator (SWMU 68). The 1F Oil/Water Separator Feed Trench (SWMU 69) is visible just south of the unit.
